Limited Visual Dam Safety Inspection Summary Report

MA-057

Kahoma Reservoir

May 2006

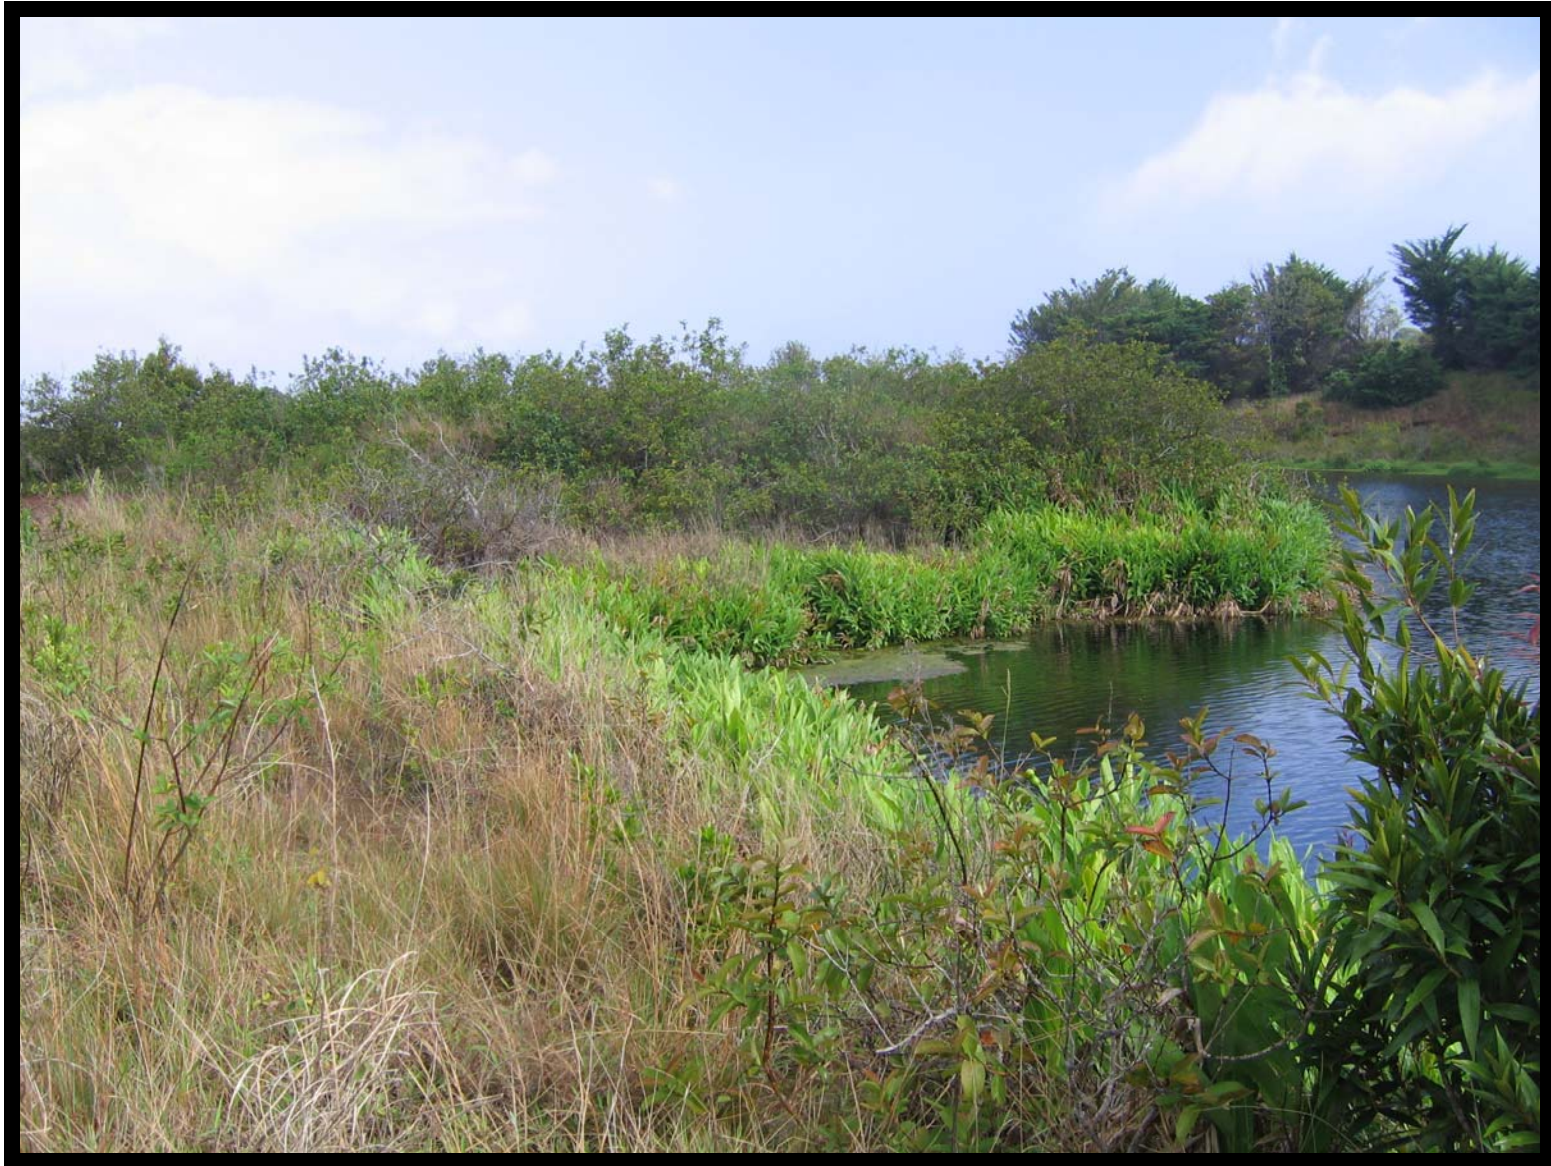
057 View of heavy overgrowth of upslopes of south dam.

2) HEAVY GROWTH NEEDS TO BE REMOVED TO PROMOTE VISUAL INSPECTION OF SLOPES.

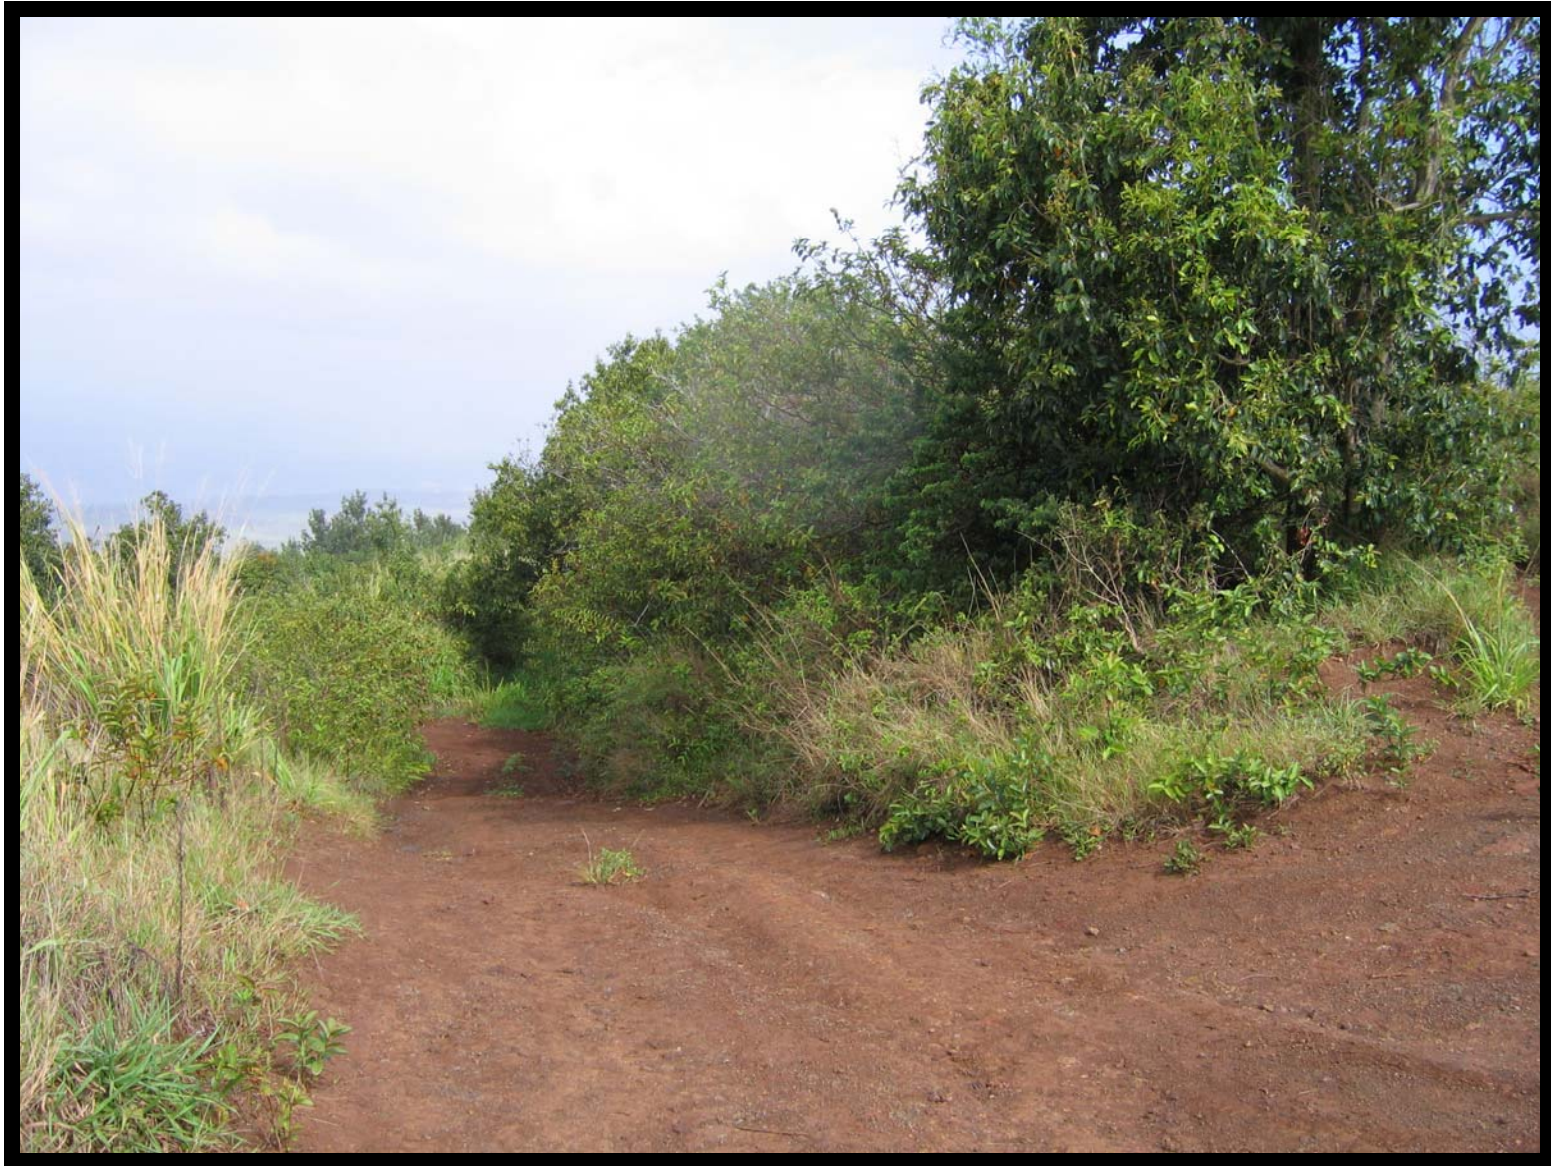
057 Access Road Along Crest - View of access road looking south.

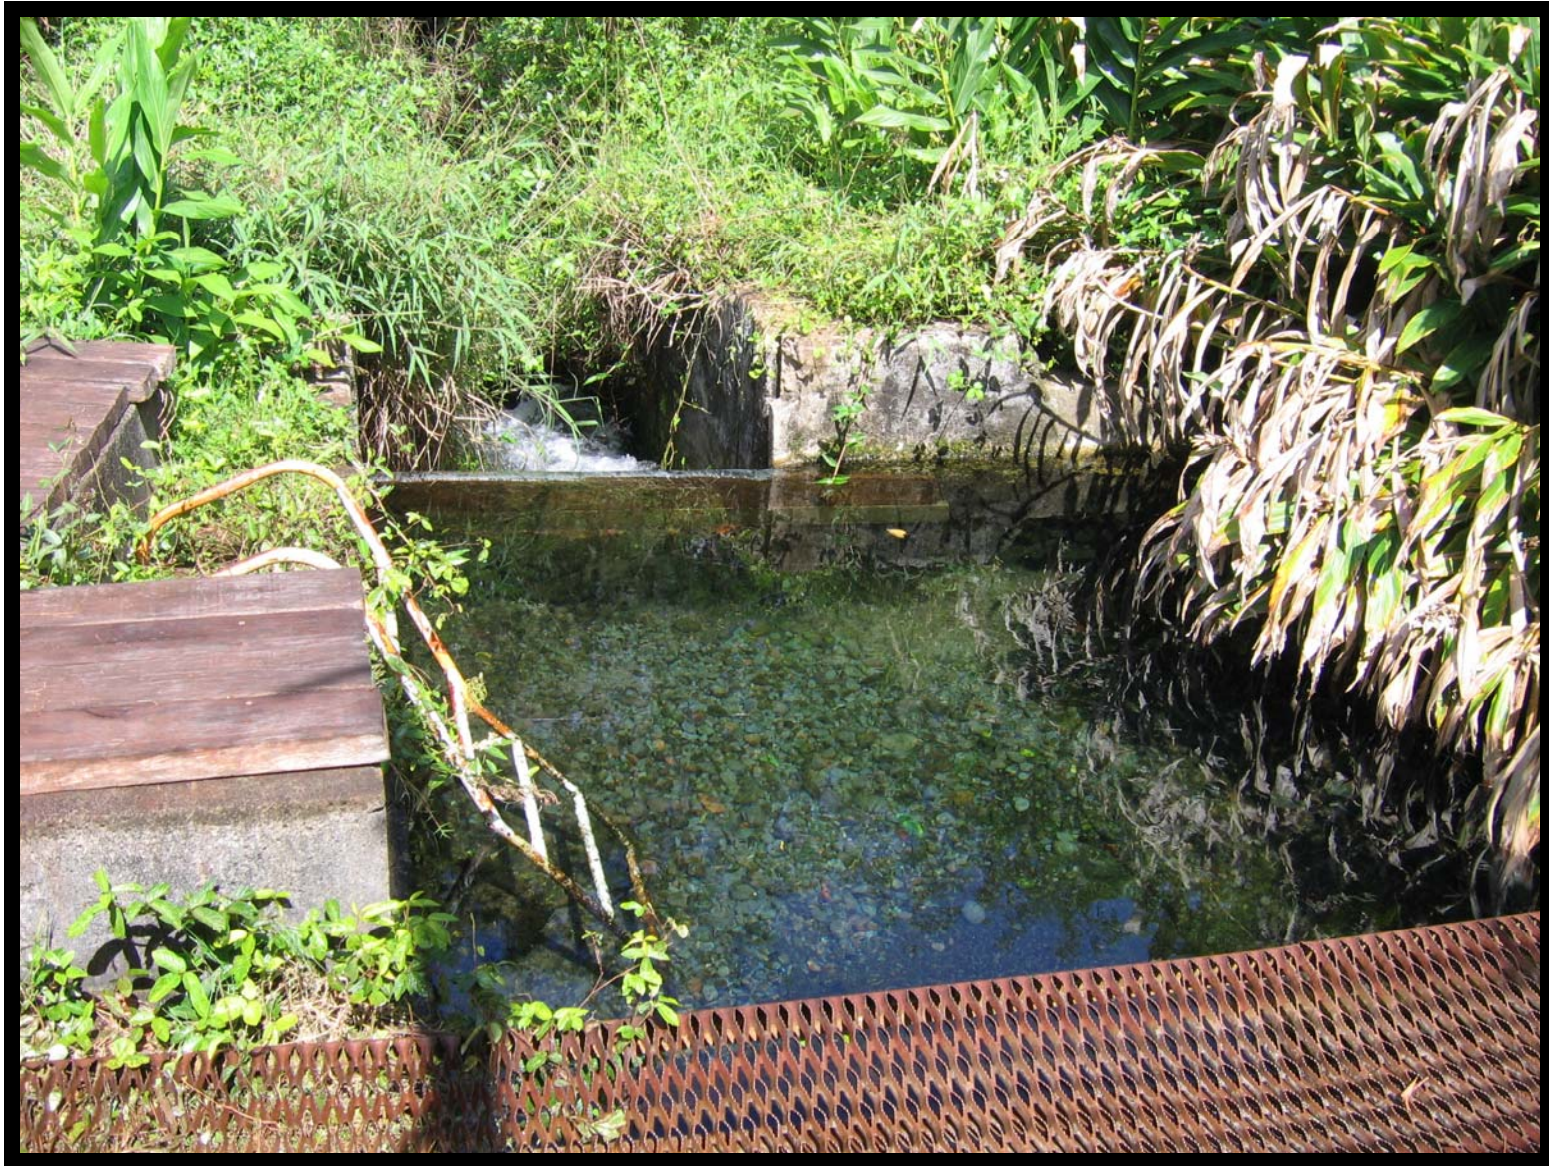
057 View of gated culvert inlet works looking toward reservoir.

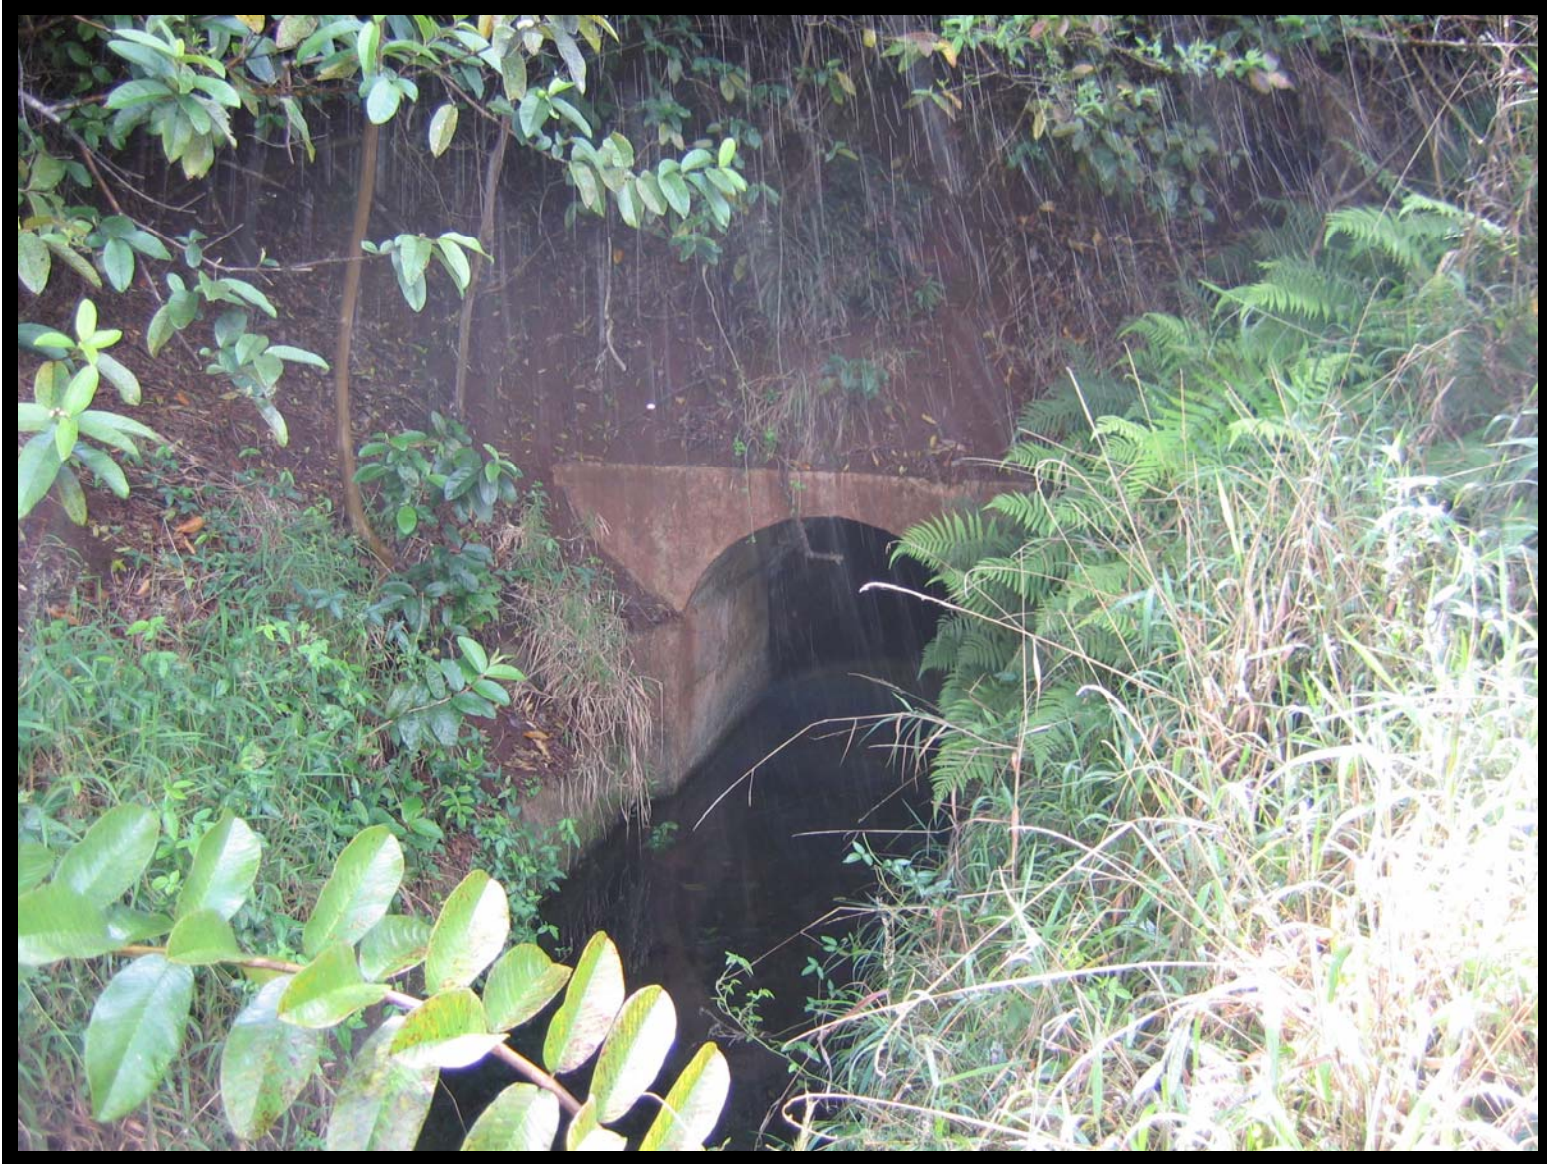
Inlet consists of a 3-ft diameter tunnel, day lighting into a ditch that was in satisfactory condition.

057 View of inlet tunnel coming out of hillside into inlet channel.

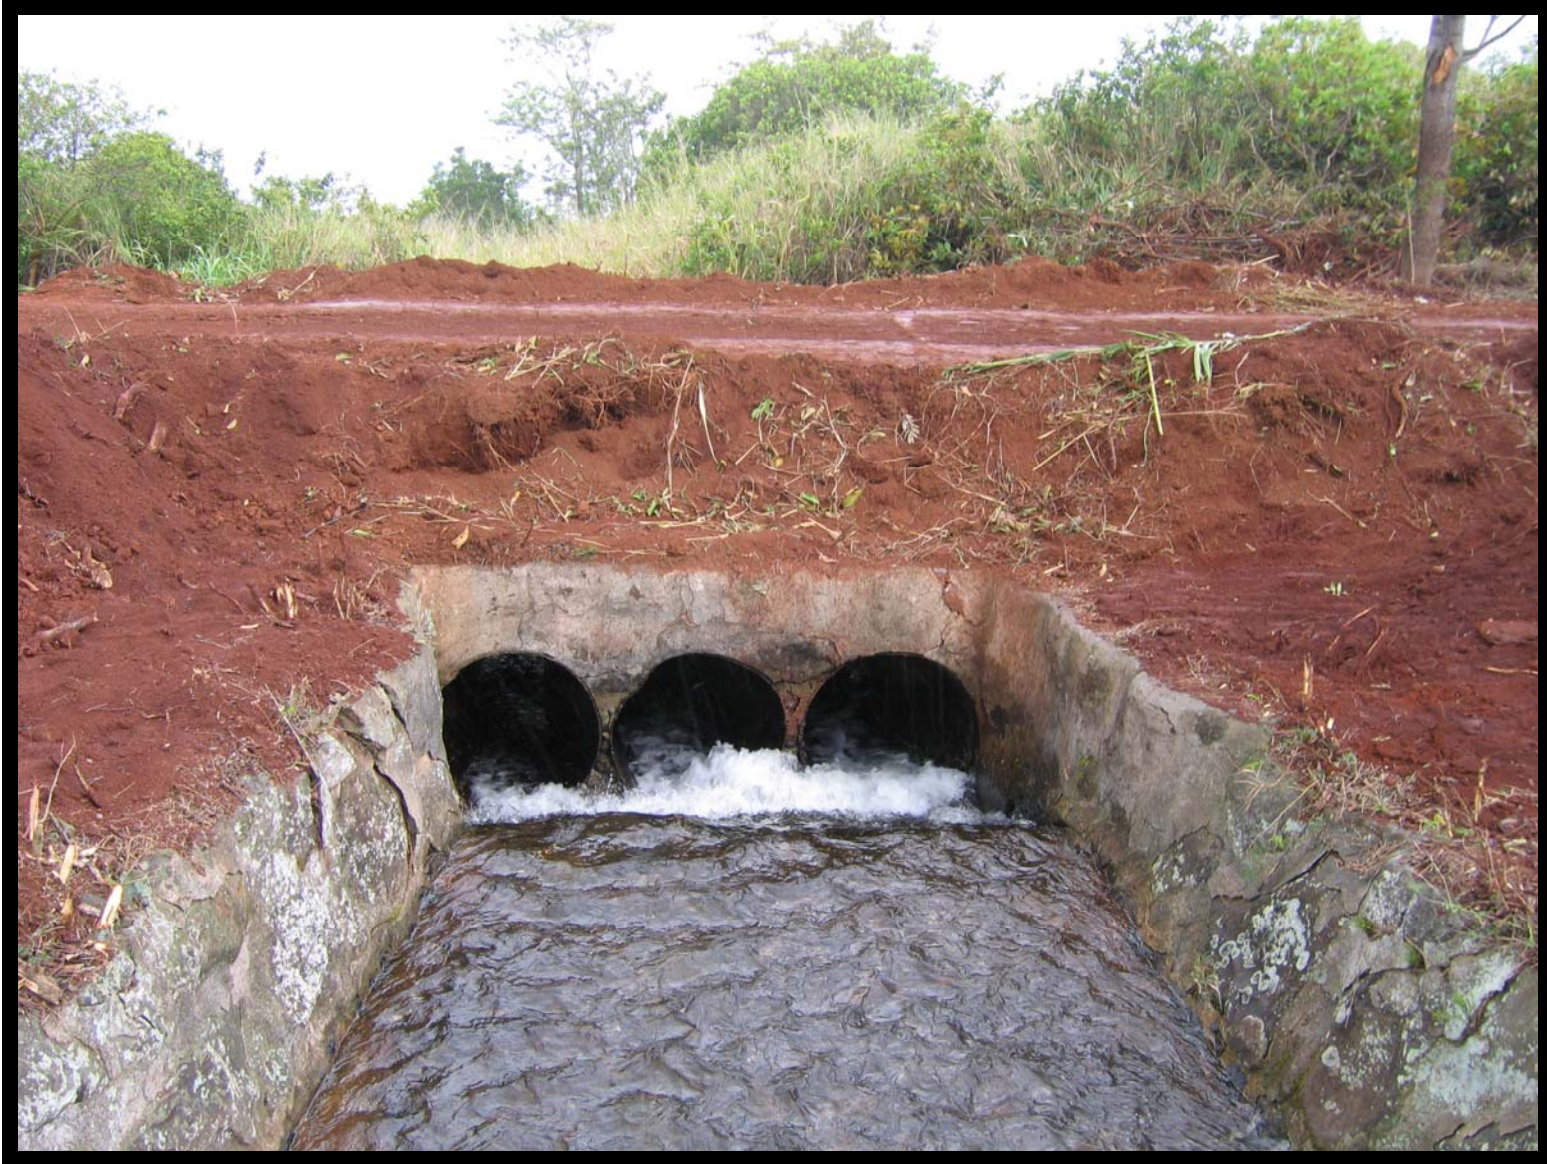
057 View of flume of spillway looking downstream.

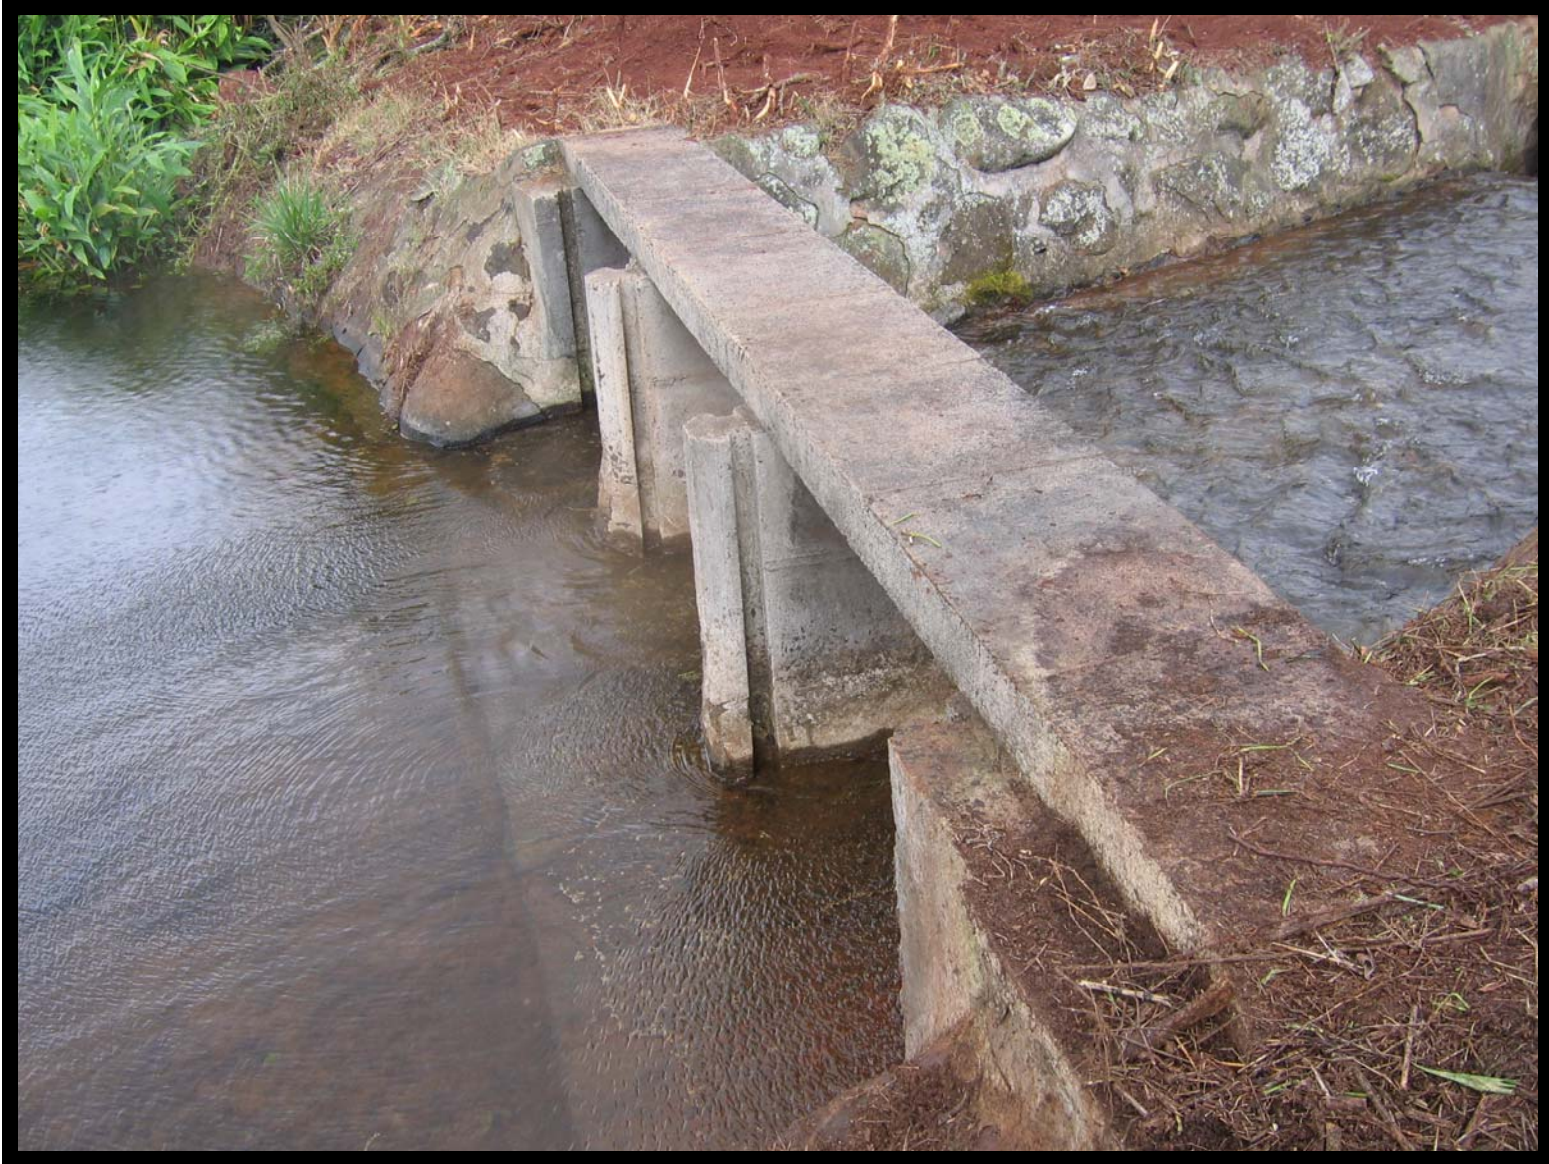
- a. The outlet works appeared to be in satisfactory condition, no corrective actions are required at this time.

057 View of spillway\outlet works that were ungated.
